Manhole Inspection Summary

Manhole # S31G__027MH

Insp Date: **12/16/08 1:34 PM**

Location Address: **22 S Arch St**

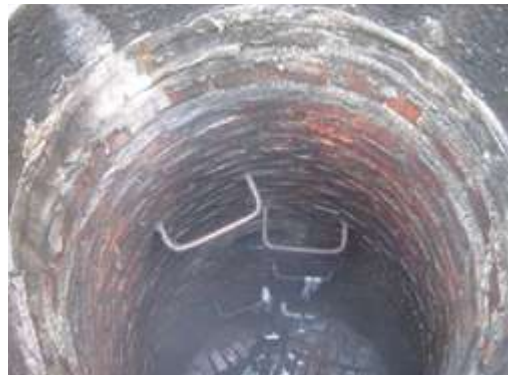
Defect 2

Infiltration: ☐ None ☒ **Joint** ☐ Cracks ☐ Mortar ☐ Roots ☐ Wall

☒ **Evidence Of Surcharge** Depth: **4** (ft.) ☐ Active Surcharge Present

chimney infiltration and evidence of surcharge on steps

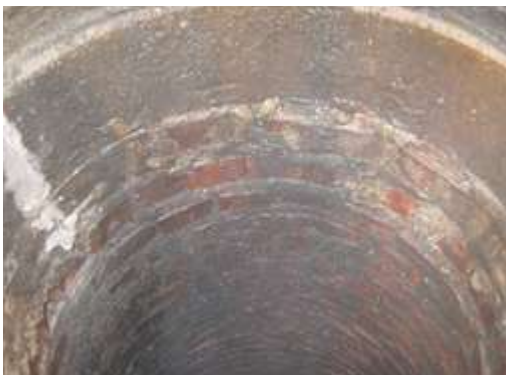
Defect 1

Condition: ☐ Sound ☐ Cracked ☒ **Leaks**

lid/frame infiltration

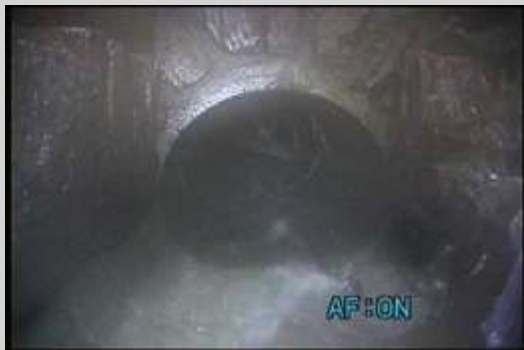
12 O'Clock Outflow

Pipe Height: **10.8** (in.) Rod and Bar (Angled)
Pipe Material: **Clay** ☐ Pipe Lined
Invert Depth: **11.47** (ft.) Flow Characteristics: **Fast**
Deposits: ☒ None ☐ Mud ☐ Sludge ☐ Debris ☐ Grease
Silt Depth: **0** (in.) Deposits Extent:
Infiltration: **None** Pipe Seal Cond: **Sound**

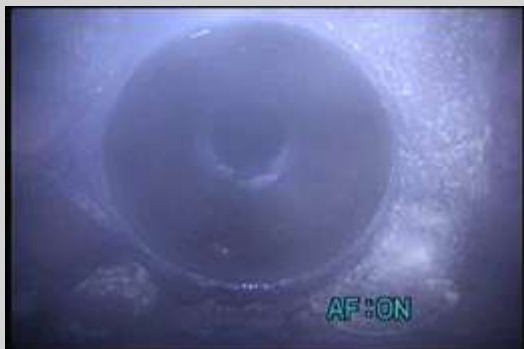
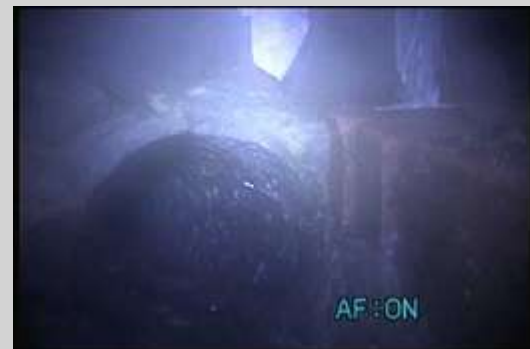
3 O'Clock Inflow

Pipe Height: **8.4** (in.) Rod and Bar (Angled)
Pipe Material: **Clay** ☐ Pipe Lined
Invert Depth: **5.53** (ft.) Flow Characteristics: **Slow**
Deposits: ☒ None ☐ Mud ☐ Sludge ☐ Debris ☐ Grease
Silt Depth: **0** (in.) Deposits Extent:
Infiltration: **None** Pipe Seal Cond: **Sound**

Drop: **Outside** Rod and Bar
Angled: **Yes** Reading: **9.73** (ft.)
Inv Depth: **10.73** (ft.)
Drop Condition: **Open**

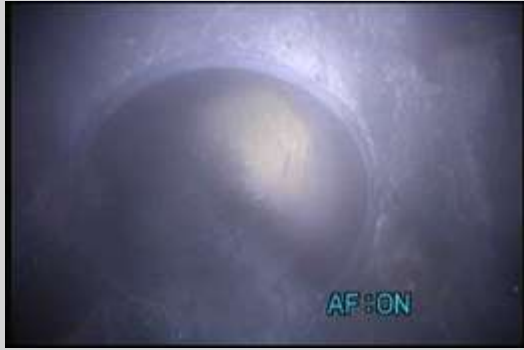
6 O'Clock Inflow

Infiltration: **None** Pipe Seal Cond: **Sound**
